WELLINGTON, KS WATER STORAGE TANK

PROJECT INFORMATION

Project Location
Wellington, Kansas

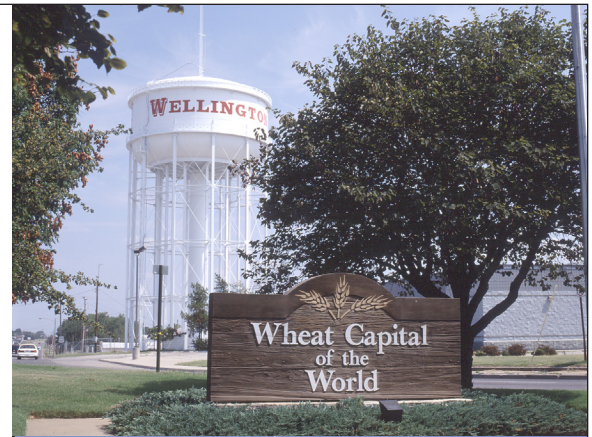
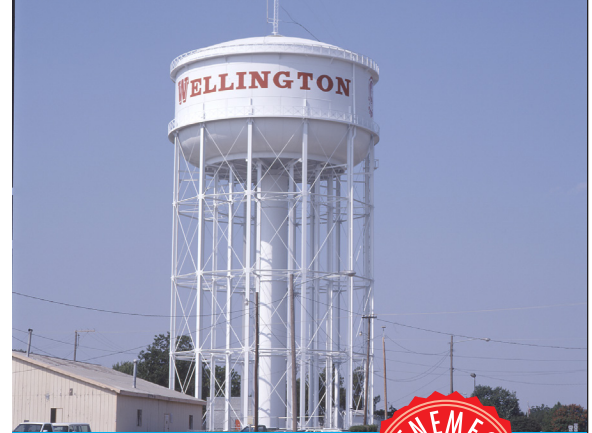
The logo on the Wellington, KS water tank was applied using Series 1075 Endura-Shield II, an aliphatic acrylic polyurethane, and Series 76 Endura-Clear, a clear aliphatic acrylic polyurethane.
