# ARKANSAS FARM BUREAU

## PROJECT INFORMATION

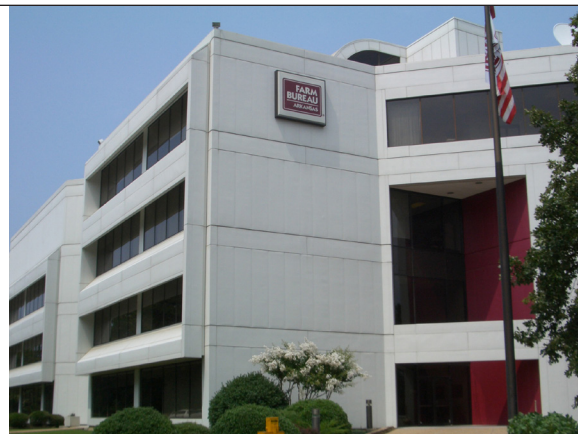
An epoxy/polyurethane coating system from Tnemec was chosen in lieu of an acrylic paint to protect the exterior of the Arkansas Farm Bureau building in Little Rock, AR. of the Arkansas Farm Bureau building in Little Rock, AR.

Back in the field the 18-year-old factory-coated steel panels on the building's exterior were pressurewashed prior to receiving a field-applied tie-coat of Series 27 F.C. Typoxy, a polyamide epoxy. "That epoxy is more compatible with existing coatings, plus it provides fast curing and rapid handling capabilities," Valentine noted. A topcoat of Series 73 Endura-Shield, an acrylic polyurethane, was then brush-and roller-applied, completing the two-coat system. Endura-Shield is highly resistant to abrasion, wet conditions and extreme weathering. Series 76 Endura-Clear, an acrylic polyurethane clear coat, was applied over existing maroon-colored accent areas to enhance the finish and extend the long-term weathering qualities of Endura-Shield.
