WADSWORTH STANDPIPE

PROJECT INFORMATION

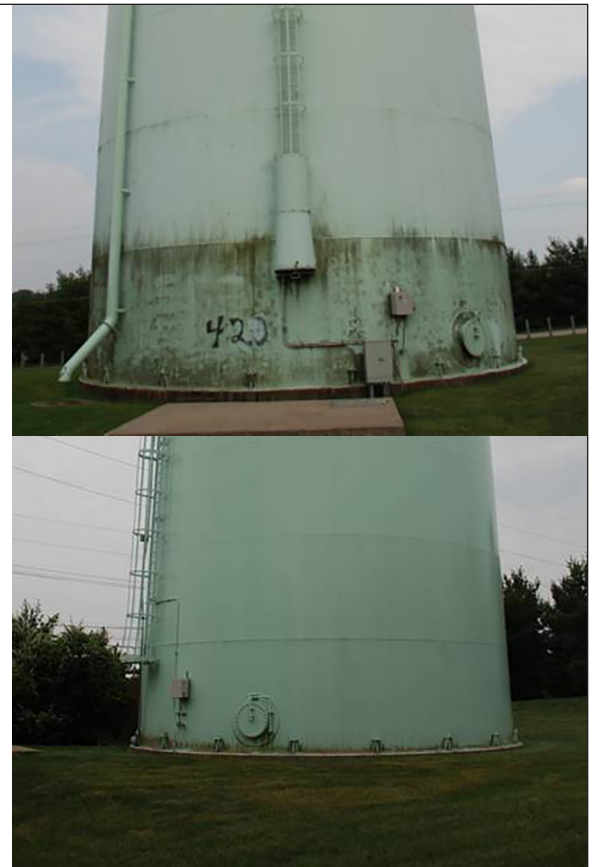
The top photo shows the mold and mildew growing on the Wadsworth standpipe when coated with an acrylic polyurethane system. The bottom photo shows very minor mildew growth due to grass clippings, after a Tnemec fluoropolymer system was applied.

Carlin has monitored the condition of the Wadsworth water tank since the HydroFlon system was applied in 2004, as well as a sister standpipe tank that was topcoated several years earlier with a standard urethane system. "I don't see the regrowth of mold and mildew with the HydroFlon coating system that I do with the standard urethane," Carlin acknowledged. "Mold and mildew have a harder time growing on the fluoropolymer surface."
