# WRIGHTSTOWN BIOSOLIDS TANK

When the Village of Wrightstown discovered a serious level of corrosion in the biosolids tank at its wastewater treatment plant, engineers took concrete measures to repair the damage using a thick-film coating system from Tnemec. "Due to excessive exposure to hydrogen sulfide (H<sub>2</sub>S) gas and biogenic sulfide corrosion, the concrete walls and ceiling were badly deteriorated and desperately needed rehabilitation," reported Tnemec coating consultant John Laird. "The biosolids tank was built and placed in service in the fall of 1998, but in less than five years severe damage had occurred."

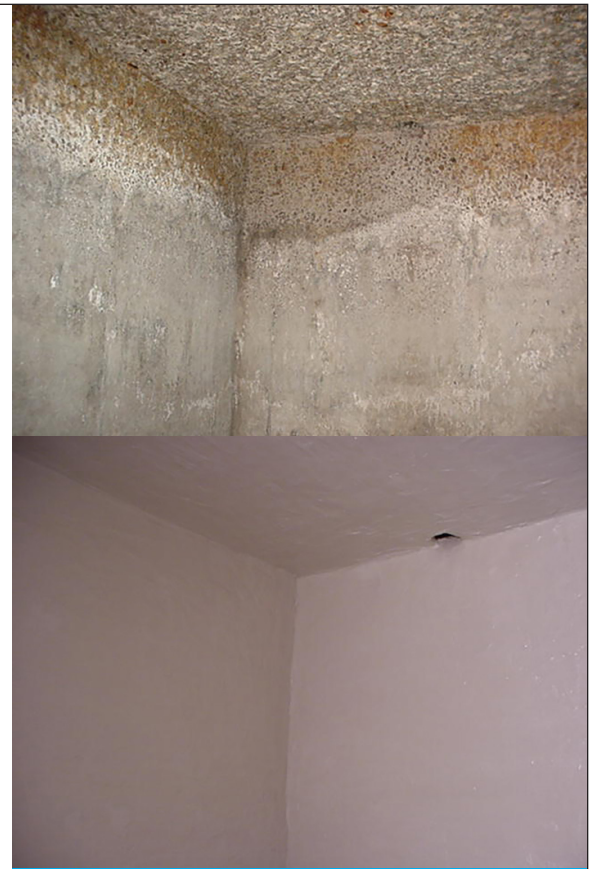
The Wrightstown Wastewater Treatment Plant biosolids concrete tank in Wisconsin was attacked above the sludge line by biogenic sulfide corrosion. Tnemec's Series 218 MortarClad, an epoxy-modified cementitious resurfacer, was applied to restore the concrete and provide a contiguous surface for coating.

The highly eroded surface of the biosolids tank was waterjetted in accordance with SSPC-SP13/NACE No. 6, ICRI-CSP 5-7 prior to application of a three-coat system consisting of:

- Series 218 MortarClad, an epoxy modified cementitious resurfacer, was applied at 1/8" following the required surface preparation. The thin overlay of Series 218 rebuilds the concrete surface to create a contiguous substrate for coating. This step is critical to achieving a monolithic topcoat by preventing bughole-induced outgassing from the entrapment within voids and crevices found in the deteriorated concrete substrate.
